Belgisch **Wegen**congres Congrès belge de la **Route**

**Comment caractériser les performances acoustiques
d'écrans antibruit installés le long des routes**

- Securing and Optimizing the Performance of Road traffic noise barriers with New methods and In-Situ Evaluation
- Recherche Européenne ...
soutenue par la **CEDR** (Conférence Européenne des Directeurs des Routes)
- Méthodes simplifiées pour caractériser les performances acoustiques intrinsèques d'écrans antibruit installés le long de routes

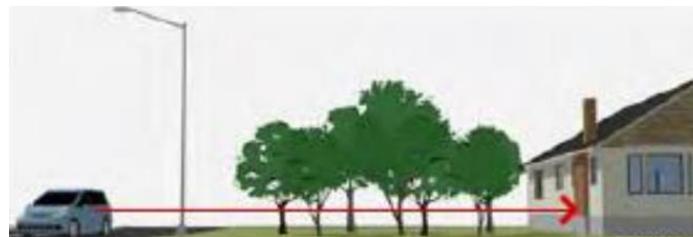
Caractérisées par l'**Insertion Loss IL**: différence de niveau de bruit **sans** et **avec** écran antibruit

sans écran antibruit (© CEDR)

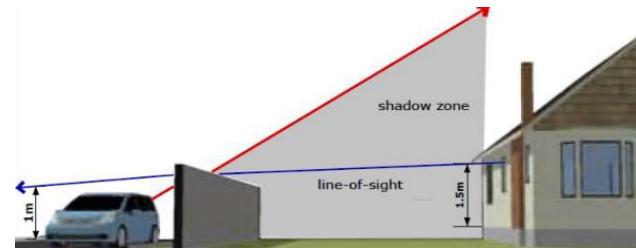
avec écran antibruit (© CEDR)

Plusieurs phénomènes physiques interviennent (T5.2 du délivrable D5.1) et les **performances intrinsèques** (inhérentes au produit) jouent aussi un rôle important ...

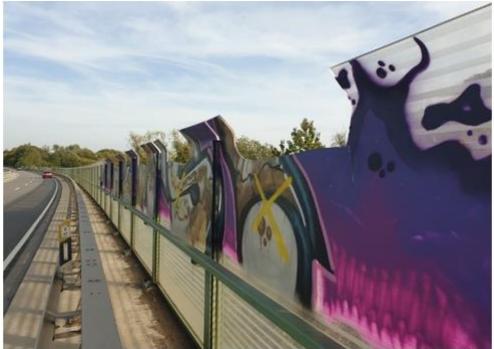
NB inspection protocol Sheet 1: Location	
road name	B42
near	Oberwaldf
emergency lane	yes
from/to km	45.7 46.5
direction	Frankfurt
from/to coordinates	50.044433 8.137693 50.044482 8.137751

NB inspection protocol Sheet 2: Construction			
main construction material	absorbing front?	absorbing back?	material of posts
acrylic glass	no	no	steel
combined with			
combined with

field no.	NB side	field height /m	defect location	Impact				view through	position /m		size /cm	
				deformation	rust	vegetation	degradation		vertical	horizontal	vertical	horizontal
				type/cause of defect								
35	front	2	at element	<input checked="" type="checkbox"/>	<input type="checkbox"/>	<input type="checkbox"/>	<input type="checkbox"/>	<input checked="" type="checkbox"/>	1.5 - 2.0	middle	35 - 35	65 - 125
57	front	2	at element	<input checked="" type="checkbox"/>	<input type="checkbox"/>	<input type="checkbox"/>	<input type="checkbox"/>	<input checked="" type="checkbox"/>	1.5 - 2.0	middle	35 - 65	65 - 125
83	front	2	at element	<input checked="" type="checkbox"/>	<input type="checkbox"/>	<input type="checkbox"/>	<input type="checkbox"/>	<input checked="" type="checkbox"/>	1.5 - 2.0	middle	35 - 65	125 - 235
84	front	2	at element	<input checked="" type="checkbox"/>	<input type="checkbox"/>	<input type="checkbox"/>	<input type="checkbox"/>	<input checked="" type="checkbox"/>	1.5 - 2.0	middle	35 - 65	125 - 235

86	front	2	at element	<input checked="" type="checkbox"/>	<input type="checkbox"/>	<input type="checkbox"/>	<input type="checkbox"/>	<input checked="" type="checkbox"/>	1.5 - 2.0	middle	35 - 35	65 - 125
87	front	2	at element	<input checked="" type="checkbox"/>	<input type="checkbox"/>	<input type="checkbox"/>	<input type="checkbox"/>	<input checked="" type="checkbox"/>	1.5 - 2.0	middle	35 - 65	65 - 125
89	front	2	at element	<input checked="" type="checkbox"/>	<input type="checkbox"/>	<input type="checkbox"/>	<input type="checkbox"/>	<input checked="" type="checkbox"/>	1.5 - 2.0	middle	35 - 65	125 - 235

NB inspection protocol Sheet 4: Acoustic assessment					
Assessment for each NB field individually			Estimated overall assessment (superposition)		
field no.	acoustic condition	critical radius /m	field no.	acoustic condition	critical radius /m
35	G	5	35	G	5
57	S	9	57	G	9
83	Q	17	83	Q	39
84	G	8	84	Q	44
86	S	5	86	Q	48
87	G	9	87	Q	46
89	Q	17	89	Q	38

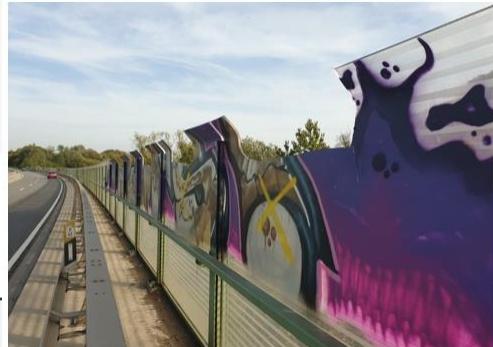
NB inspection protocol		
Sheet 1: Location		
road name	<u>B42</u>	
near	<u>Oberwallluf</u>	
emergency lane	<u>yes</u>	
from/to km	<u>45.7</u>	<u>46.5</u>
direction	<u>Frankfurt</u>	
from/to coordinates	<u>50.044433</u>	<u>8.137693</u>
	<u>50.044482</u>	<u>8.137751</u>

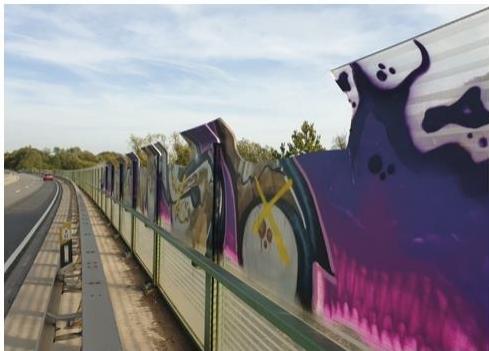
NB inspection protocol				
Sheet 2: Construction				
main construction material	<u>acrylic glass</u>	absorbing front?	<u>no</u>	absorbing back?
combined with			<u>no</u>	<u>steel</u>
combined with

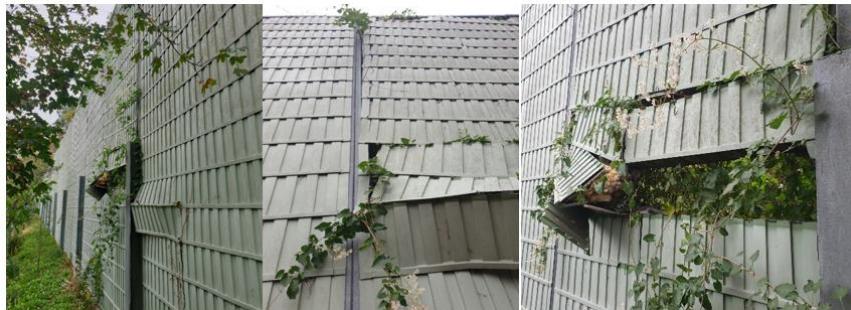
NB inspection protocol Sheet 1: Location	
road name	B45
near	Rodgau
emergency lane	yes
from/to km	107.0 107.5
direction	Dieburg
from/to coordinates	50.009051 8.897331 50.008208 8.897556

NB inspection protocol Sheet 2: Construction			
main construction material	plastics	absorbing front?	yes
		absorbing back?	yes
		material of posts	steel
combined with			
combined with

NB inspection protocol Sheet 3: Defects											
field no.	NB side	field height /m	defect location	type/cause of defect	view through		position /m		size /cm		additional notes (e.g. on visual/aural impression, absorption material, environmental conditions, general condition, reference to photographs...)
					impad	deformation	rust	vegetation	degradation	lacking material	
43	front	5	at element	✓	✓	✓	✓	✓	✓	✓	yes 1.5 - 2.0
43	front	5	between element and post	✓	✓	✓	✓	✓	✓	✓	yes 3.0 - 3.5
											middle
											15 - 35
											235 - 415
											125 - 235
											8 - 15

Assessment for each NB field individually			Estimated overall assessment (superposition)		
field no.	acoustic condition	critical radius /m	field no.	acoustic condition	critical radius /m
43	Q	32	43	D	59
43	Q	27	43	D	59

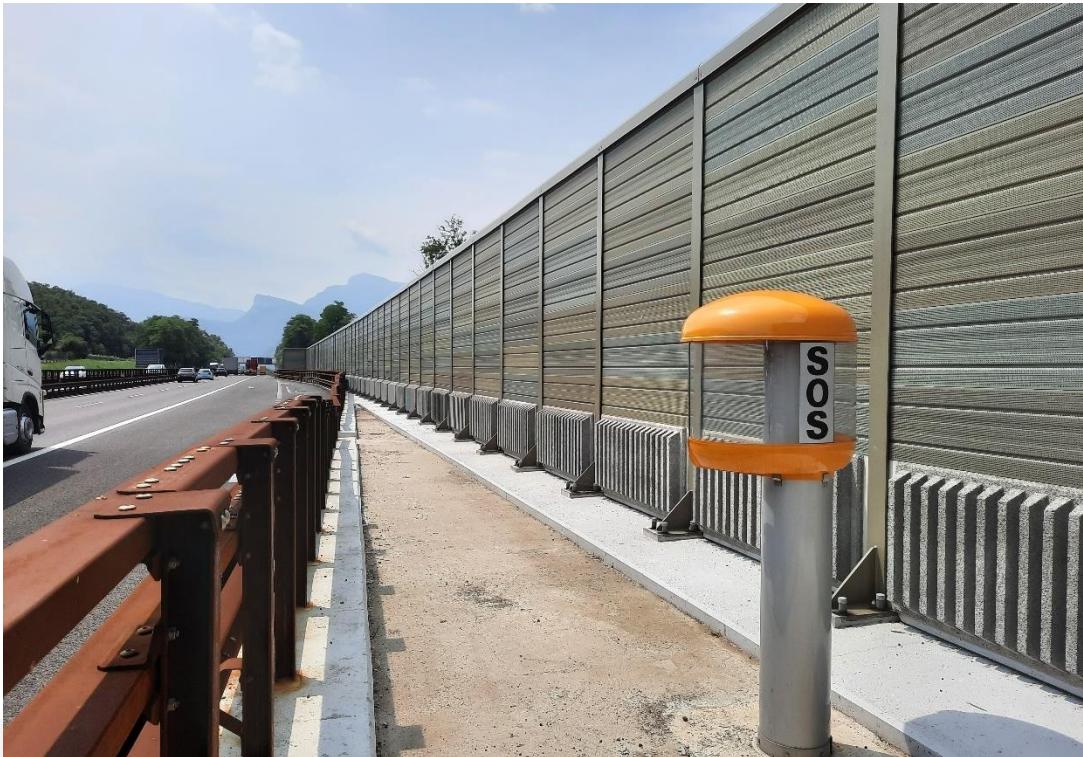
Exemple sur l'autoroute A22 en Italie

Tests entre 10:00 and 16:00 (6 heures)

Barrière antibruit métallique:

- Longueur 600 mL
- Hauteur 5,00 mH
- Poteaux tous les 3,00 m

22 tests d'absorption

11 tests d'isolation
