## SOPRANOISE

Hoe de akoestische prestaties van geluidschermen  
geïnstalleerd langs wegen te karakteriseren

- Securing and Optimizing the Performance of Road traffic noise barriers with New methods and In-Situ Evaluation
- Europees Onderzoek ...  
Gesteund door de **CEDR** (Conference Of European Directors of Roads)
- Vereenvoudigde methodes om de intrinsieke akoestische prestaties van geluidschermen geïnstalleerd langs wegen te karakteriseren

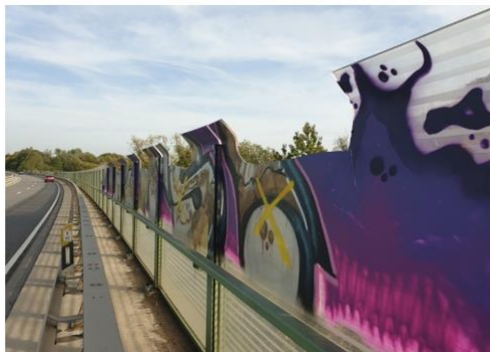
**NB inspection protocol**  
**Sheet 1: Location**

road name **B42**

near **Oberwolf**

emergency lane **yes**

from/to km **45.7** | **46.5**

direction **Frankfurt**

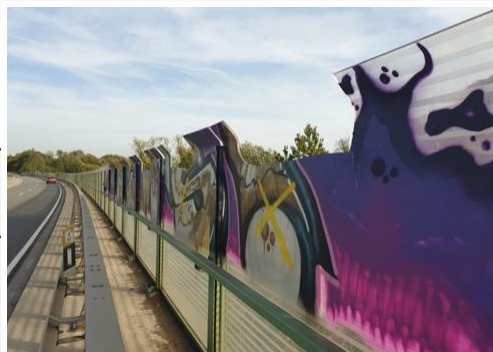
## NB inspection protocol Sheet 4: Acoustic assessment

### Assessment for each NB field individually

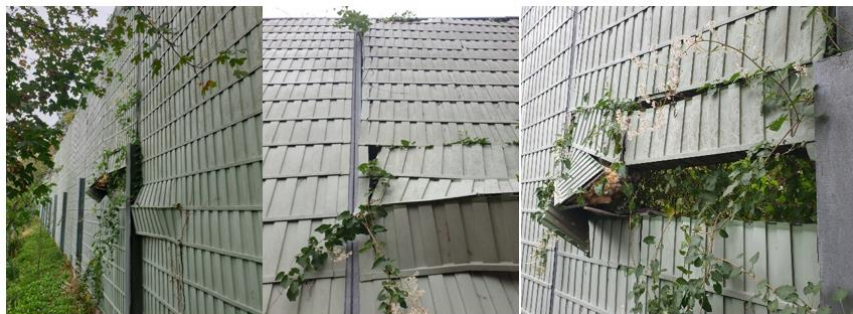
| NB inspection protocol | | | | | | | | | | | | | | | | |
|---|---|---|---|---|---|---|---|---|---|---|---|---|---|---|---|--|
| | | | | | impact | deformation | rust | vegetation | degradation | missing material | | | | | additional notes<br>(e.g. on visual/aural impression, absorption material, environmental conditions, general condition, reference to photographs ...) | |
| field no. | NB side | field height /m | defect location | type/cause of defect | | | | | | | view through | vertical | horizontal | vertical | horizontal | |

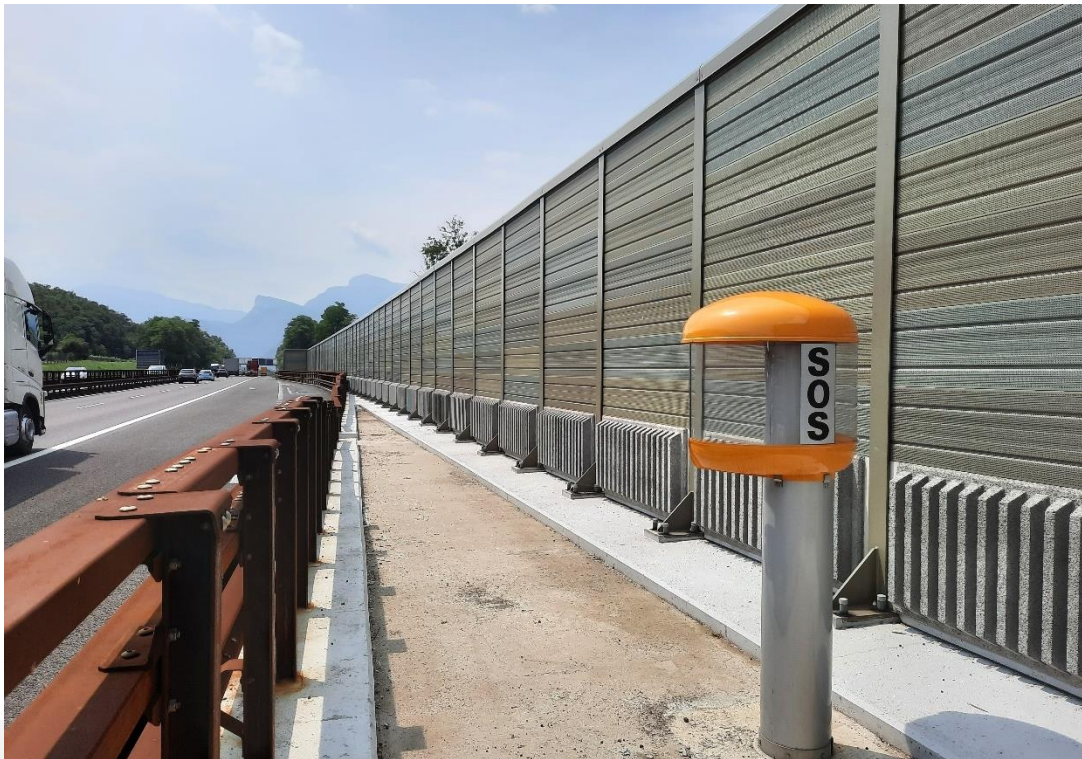
## De “snelle” SOPRA methode

### Voorbeeld op autoweg A22 in Italië

Testen tussen 10 en 16 uur (6 uren)

11 testen van de isolatie
